# THE RESTORATION PROJECT THAT BROKE THE MOLD

The Wyman Towers is a 90-year-old property building across the street from Johns Hopkins University in Baltimore, MD. The property manager was planning to refinance the building last fall. When the home inspector came to visit, it appeared many of the balconies were suffering cracks from weight or old age.

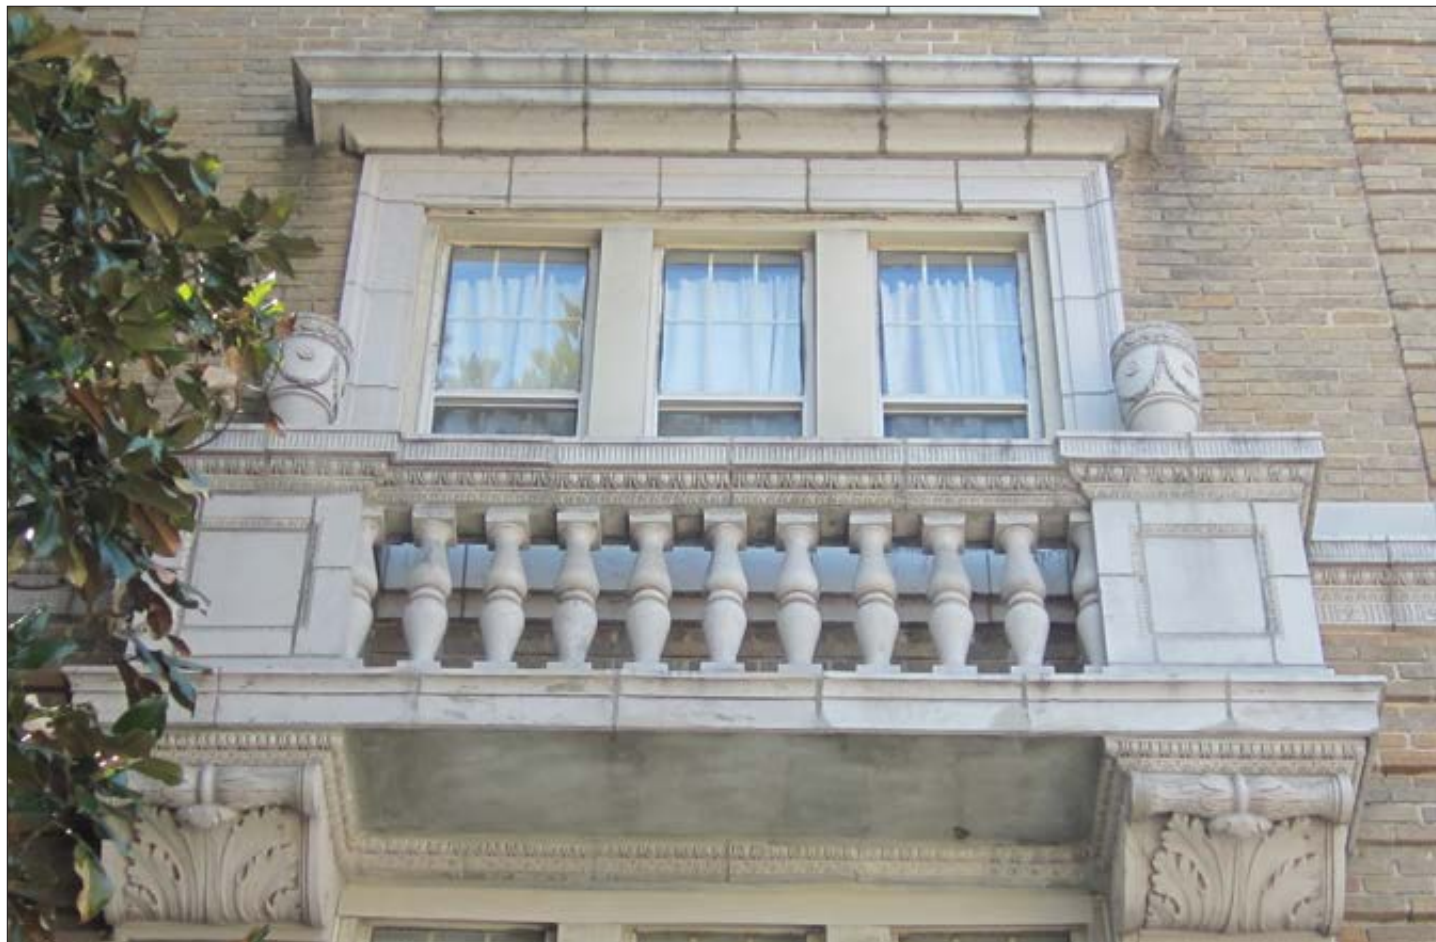
Top: Balcony "H" restored to its former glory. Reconstructing new terra cotta molds would have been extremely expensive by today's standards, so it was more cost-effective to patch and repair the material around the steel beams.

Reconstructing new terra cotta molds would have been extremely expensive by today's standards, so it was more cost-effective to patch and repair the material around the steel beams.

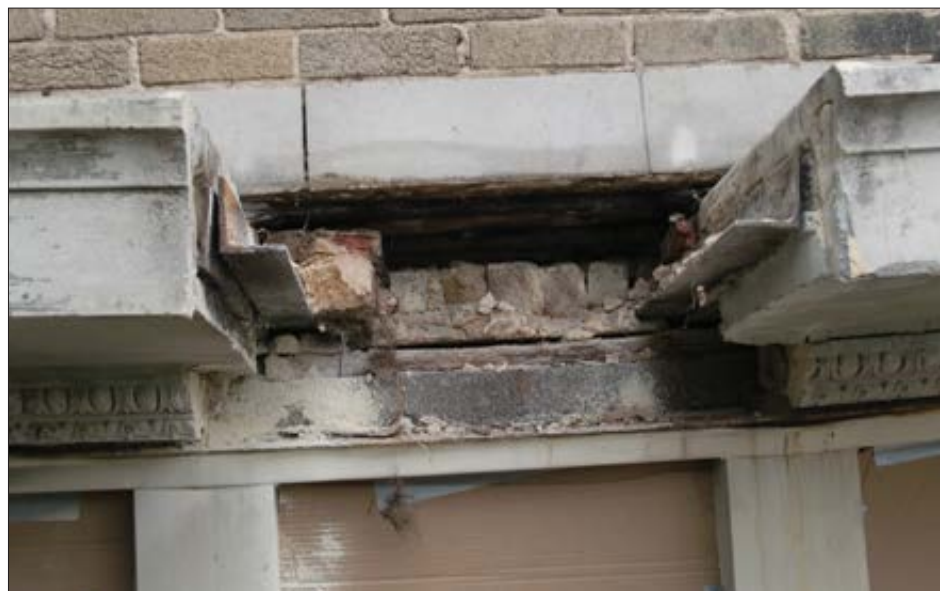
Left: Balcony "H" in progress, with one floor tile removed. The tiles weighed in at 171 pounds apiece. Also visible here is the exposed, weakened steel support

Almost all of the balconies and balusters had internal fractures caused by wear and tear or intrusive vine growth, which over time had weakened the whole support system from the inside. Monroe later found out that a chunk of railing had fallen on a parked car in the alley behind the building. So even though the project kept growing, and thus the cost was increasing, it was clear that the severity of the damage was real.

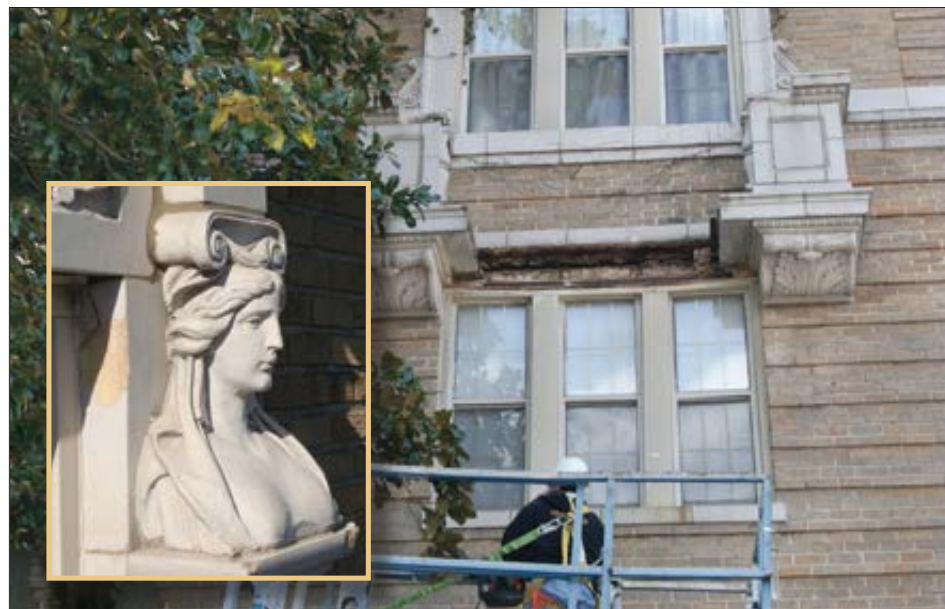
Top: Hilgartner workers on the scaffolding sport mandatory safety gear, including hard hats and harnesses. Hilgartner training for restoration includes working on multi-story buildings. Bottom photos and Inset, top: Full view of an upper floor balcony restoration, and a close-up of a terra cotta pilaster—preserving a jewel of architectural ornamentation.

There are still two balconies on the 8th floor that will be repaired in the near future. The owners are pleased with the work, and the new collaborative working conditions seem a welcome change of pace for all involved. From Monroe's perspective, this adventure has widened the horizons for the company.
